Manhole Inspection Summary

Manhole # S19Y__019MH

Location Address: **1941 griffis av**

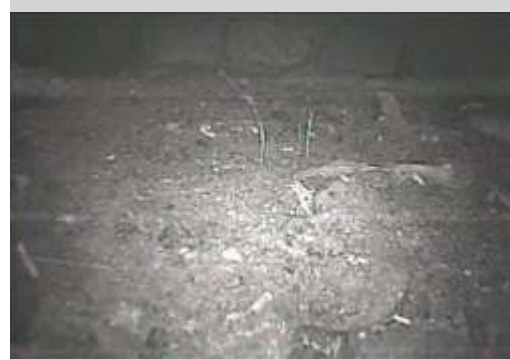
Defect 8

Condition: ☐ Sound ☐ Cracked ☐ Root Intrusion ☐ Deteriorated ☐ Leaks ☒ **Debris**

debris on bench

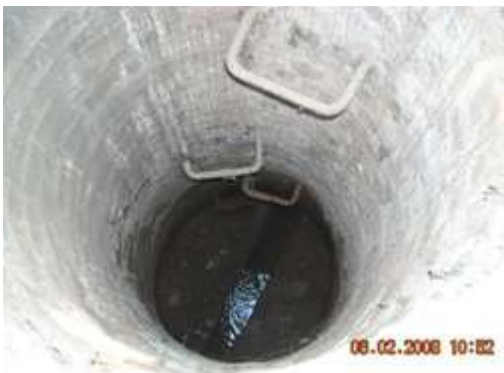
Defect 7

Steps Count: **4** Missing: **0** ☒ **Corroded**

corroded steps

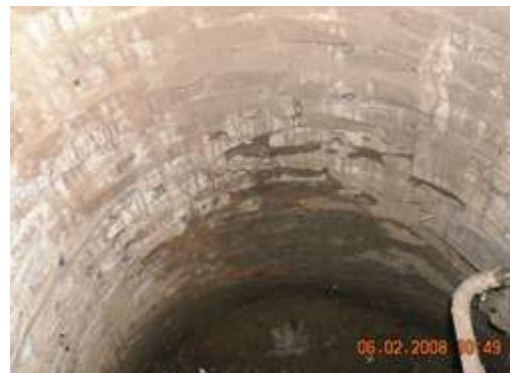
Defect 6

Infiltration: ☐ None ☒ **Joint** ☐ Cracks ☐ Mortar ☐ Roots ☒ **Wall**

infiltration @ corbel wall

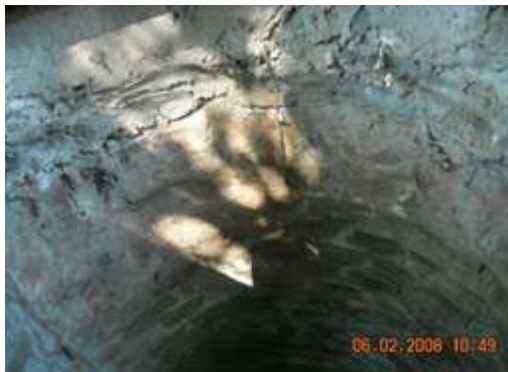
Defect 5

infiltration @ chimney/corbel joint

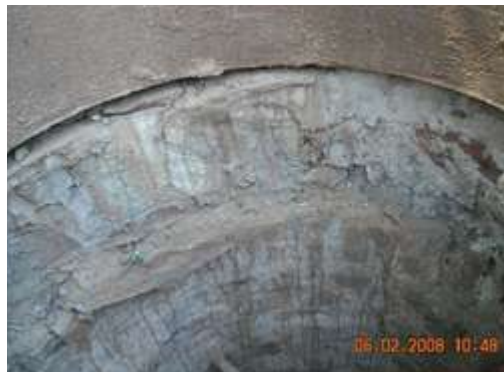
Defect 4

Infiltration: ☐ None ☒ **Joint** ☐ Cracks ☐ Mortar ☐ Roots ☐ Wall

infiltration @ chimney/frame joint

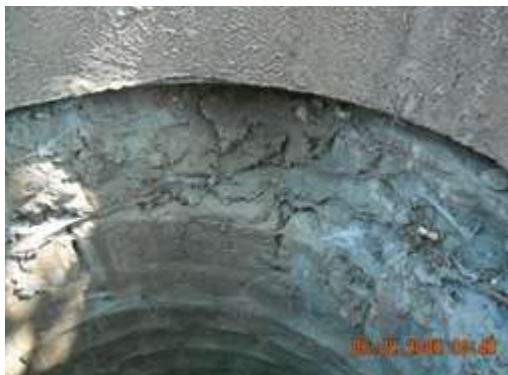
Defect 3

Condition: ☐ Sound ☐ Cracked ☐ Root Intrusion ☐ Loose Brick ☒ **Deteriorated**

deteriorated chimney

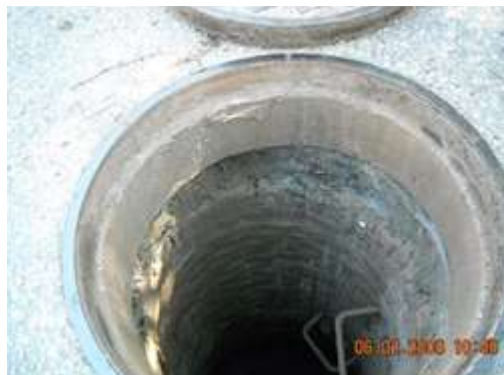
Defect 2

Frame Offset: **1** (in.) Condition: ☐ Sound ☐ Cracked ☒ **Leaks**

frame leaks

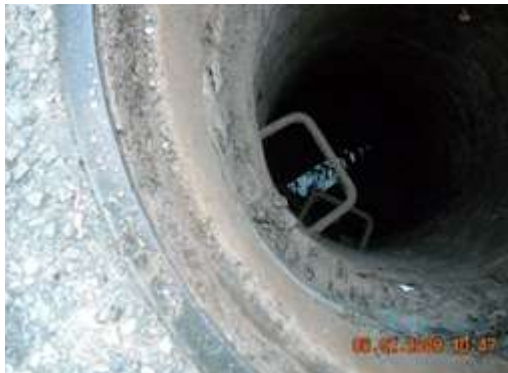
Defect 1

frame offset

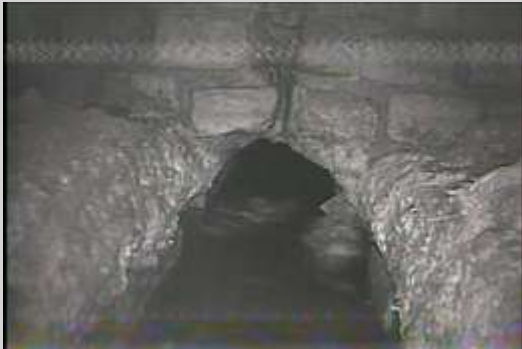
12 O'Clock Outflow

8 in. Circular Gravity Sewer
Pipe Out @ 12 O'Clock

Pipe Height: **8.4** (in.) Rod and Bar (Angled)
Pipe Material: **Clay** ☐ Pipe Lined
Invert Depth: **11.72** (ft.) Flow Characteristics: **Slow**
Deposits: ☐ None ☐ Mud ☐ Sludge ☐ Debris ☒ **Grease**
Silt Depth: **3** (in.) Deposits Extent: **Medium**
Infiltration: **None** Pipe Seal Cond: **Unknown**

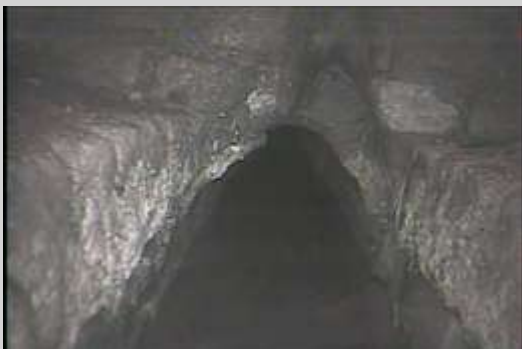
6 O'Clock Inflow

8 in. Circular Gravity Sewer
Pipe In @ 6 O'Clock

Pipe Height: **8.4** (in.) Rod and Bar (Angled)
Pipe Material: **Clay** ☐ Pipe Lined
Invert Depth: **11.63** (ft.) Flow Characteristics: **Slow**
Deposits: ☐ None ☐ Mud ☐ Sludge ☐ Debris ☒ **Grease**
Silt Depth: **2** (in.) Deposits Extent: **Medium**
Infiltration: **None** Pipe Seal Cond: **Unknown**
